AquaDance®

Premium 6-setting Showerhead

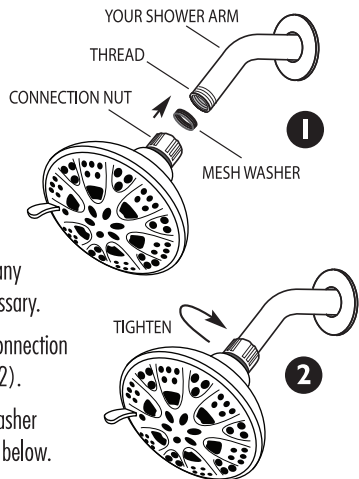
1. Remove old shower head by turning it counter-clockwise. Remove any excess material left on Shower Arm threads. Use steel wool if necessary.
2. Make sure Mesh Washer is positioned FLAT and STRAIGHT inside Connection Nut (Fig. 1). Hand tighten Connection Nut onto Shower Arm (Fig. 2).

WARNING: DO NOT OVERTIGHTEN Connection Nut as it may cause Washer to dislocate and be squeezed into Shower Arm. If leakage occurs, see below.

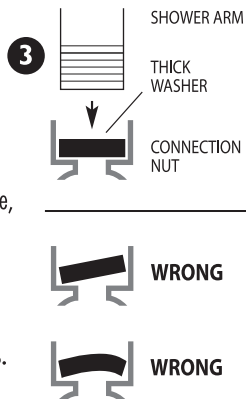
Leakage between Connection Nut and your Shower Arm is often caused by Washer inside Connection Nut not pressing evenly against edge of Shower Arm Thread (fig. 3). This is usually the result of Washer not nested correctly. To seal properly, Washer must stay FLAT and STRAIGHT inside Connection Nut (Fig.3).

Unscrew Shower Head from Shower Arm and adjust position of Washer by pushing it down and pressing around its edges with your finger or pointed tool, until it nests completely FLAT and STRAIGHT inside Nut (fig. 3).

If Washer is positioned correctly but leak remains, it is likely the result of Damaged Washer Surface or Worn Shower Arm Threads. If you suspect Damaged Washer Surface, using screwdriver or pointed metal tool, gently pull out Washer from Connection Nut, turn it up-side-down and nest back into Nut. If the leak is caused by Worn Shower Arm Threads, wrap some Plumber's Tape around Shower Arm threads.
